INDOOR AIR QUALITY ASSESSMENT

Augustine Belmonte Middle School 25 Dow Street Saugus, MA 01906

Prepared by:
Massachusetts Department of Public Health
Center for Environmental Health
Emergency Response/Indoor Air Quality Program
January 2007

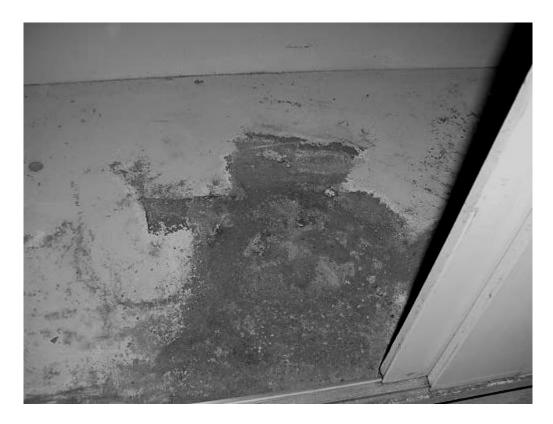
As discussed, the assessment was prompted by reports of potential sources of mold growth observed in the building. CEH staff were asked in particular, to examine the sink cabinet in classroom 116 for mold growth. Although no visible mold was observed, evidence of historic water damage was seen in the form of rust (Picture 1). The area was dry at the time of the assessment and no further leaks were reported or observed.

Rusted Interior of Sink in Classroom

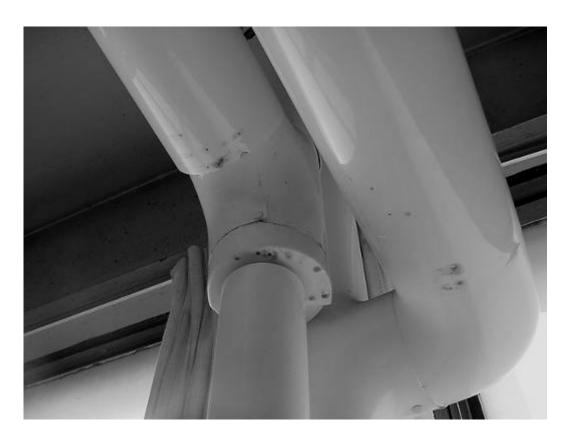
Concerns were raised regarding mold growth from a pipe leak in room 111. No water damaged materials were observed around or beneath the (overhead) pipe in this area; however, the surface of the plastic pipe covering was discolored (Picture 2). CEH staff recommended that the surface of the plastic pipe covering be cleaned and disinfected.

Discoloration (as Indicated by Dark Stains) on Pipe Insulation in Room 111 Indicating a Historic Leak

- 12. Clean and disinfect surface of plastic pipe insulation in classroom 111. Remove insulation to inspect for moisture/mold, replace if mold growth is found.

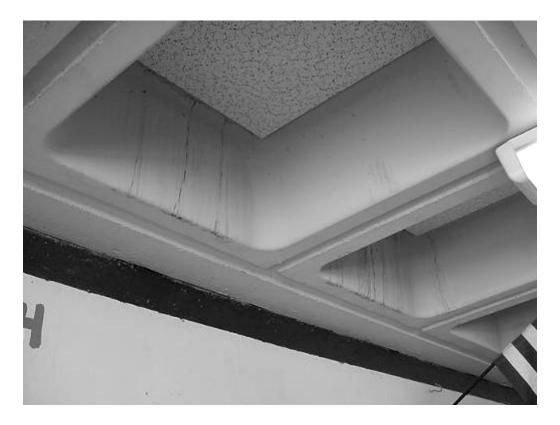
The building has had water infiltration issues through the roof and window systems over the years as evidenced by water stained concrete ceilings/tiles (Picture 3) and

Water Stains on Concrete Ceilings Indicating Former Areas of Leaks

- 15. Continue to remove/replace water damaged ceiling tiles.
- 16. Ensure all plants are equipped with drip pans. Examine drip pans periodically for mold growth and disinfect with an appropriate antimicrobial where necessary.
 Remove plants from univents.

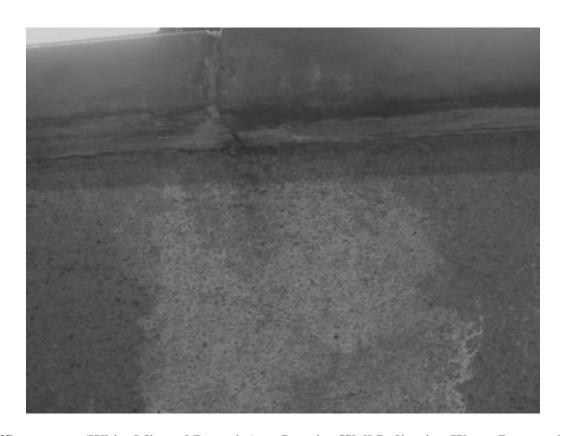
efflorescence on interior brick/plaster (Pictures 4 and 5). Efflorescence is a characteristic sign of water damage to building materials, but it is not mold growth. As moisture penetrates and works its way through building materials (e.g., plaster), water-soluble compounds dissolve, creating a solution. As this solution moves to the surface, the water evaporates, leaving behind white, powdery mineral deposits.

Efflorescence (White Mineral Deposits) on Interior Wall Indicating Water Penetration

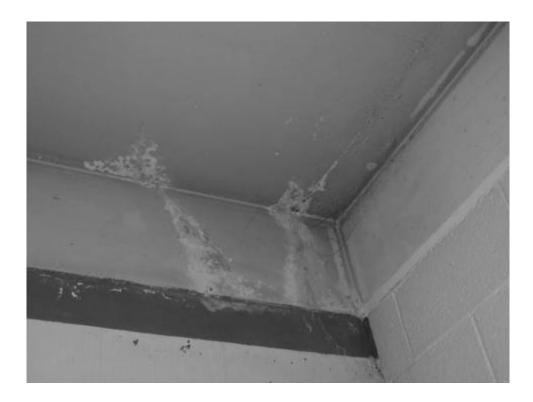
Peeling Paint and Efflorescence (White Mineral Deposits) on Interior Wall/Ceiling Indicating Water Penetration

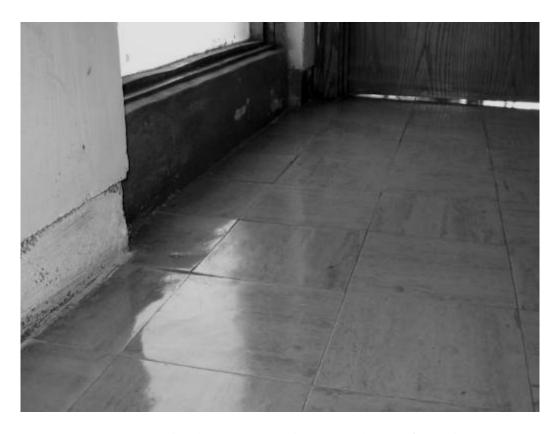
To prevent further water penetration the roof was reportedly repaired and attempts were made to seal windows. However, ongoing water penetration issues were reported in the 200/300-wing, particularly room 306-A, where standing water and loose floor tiles were observed (Pictures 6 and 7). In several rooms, building occupants were storing porous items in the general areas of window leaks, which caused the stored materials to become water-damaged (Picture 8). Water-damaged porous materials can serve as a medium for mold and should be discarded or relocated *away* from moisture sources.

Loosened Floor Tiles in Room 306-A along Windows/Exterior Wall

Remove items inside cabinet, inspect and discard if water damaged.
- 9. Remediate any water damaged materials in room 306-A (and in any other areas) in a manner consistent with recommendations found in "Mold Remediation in Schools and Commercial Buildings" published by the US EPA (US EPA, 2001). Copies of this

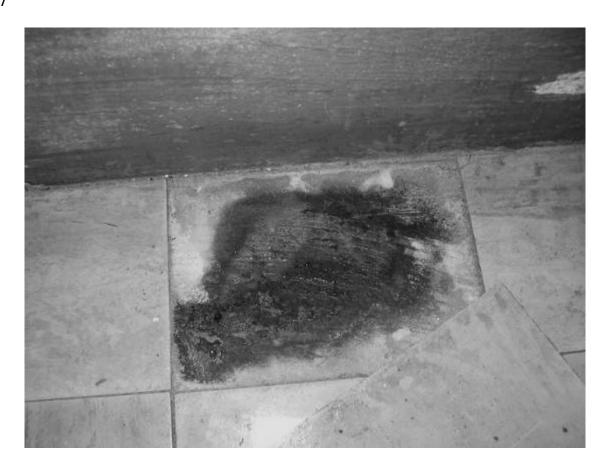
Close-Up of Beaded Water/Loosened Floor Tile in Room 306-A

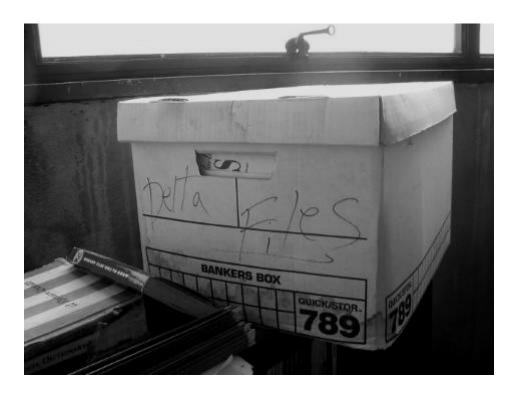
Water Damaged Porous Materials

- 13. Work with school staff to identify window leaks and make repairs to prevent further water infiltration.
- 14. Refrain from storing porous items (boxes, papers, books, etc.) in areas of suspected water leaks.

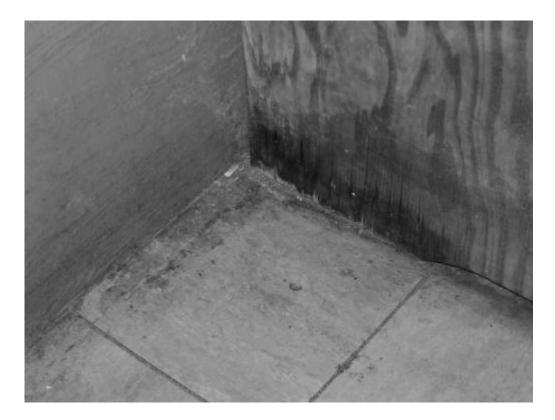
In order for building materials to support mold growth, a source of water exposure is necessary. Identification and elimination of water moistening building materials is necessary to control mold growth. Materials with increased moisture content *over normal* concentrations may indicate the possible presence of mold growth. As indicated, moisture content was measured with a Delmhorst Moisture Detector equipped with a Delmhorst Standard Probe. The Delmhorst probe is equipped with three lights that function as visual aids that indicate moisture level. Readings that activate the green light indicate a sufficiently dry or low moisture level, those that activate the yellow light indicate borderline conditions and those that activate the red light indicate elevated moisture content. Elevated moisture readings were measured from a wooden cabinet located near windows in room 306-A (Pictures 9 and 10).

Moistened Wooden Cabinet in Room 306-A

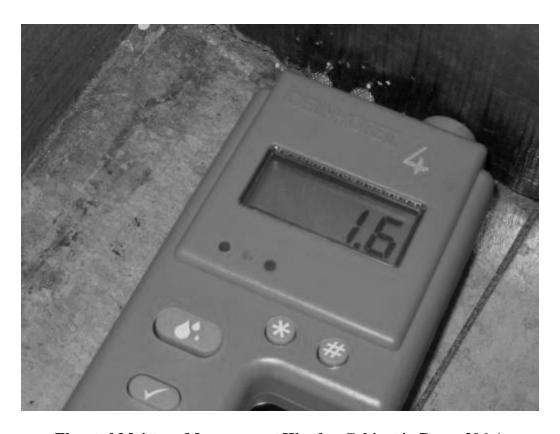
Elevated Moisture Measurement Wooden Cabinet in Room 306-A

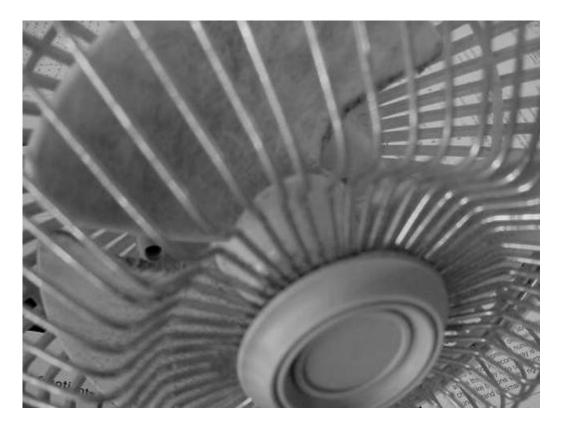
Accumulated Dust and Debris on Surface of Fan Blades in Classroom

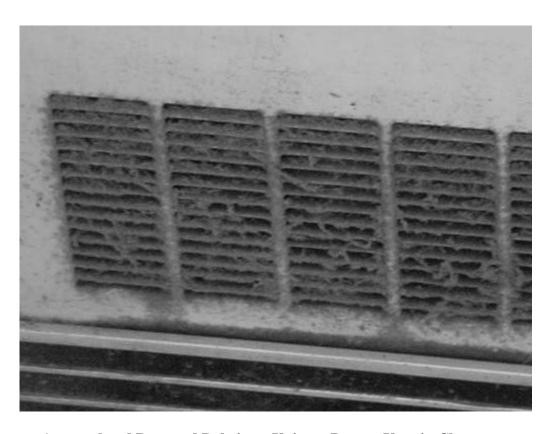
Accumulated Dust and Debris on Univent Return Vent in Classroom

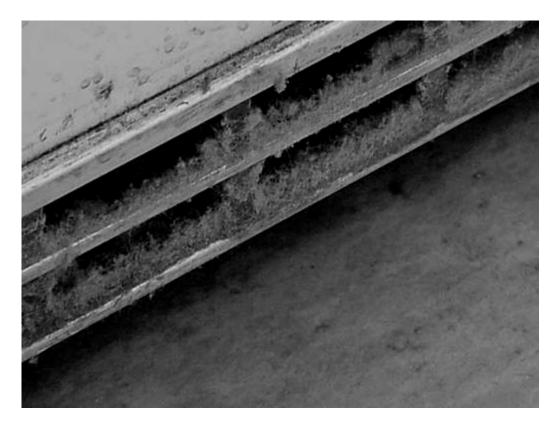
Accumulated Dust and Debris on Univent Return Vent in Classroom

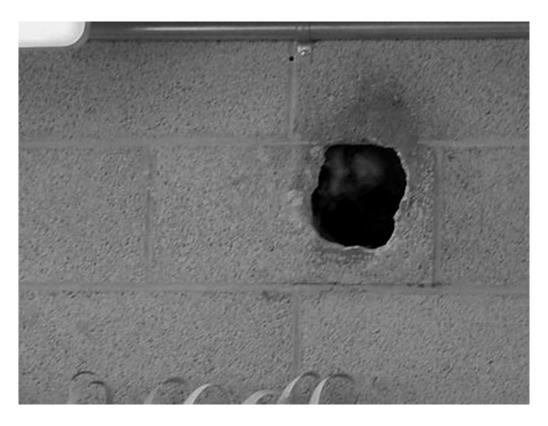
Hole in Interior Wall in Classroom

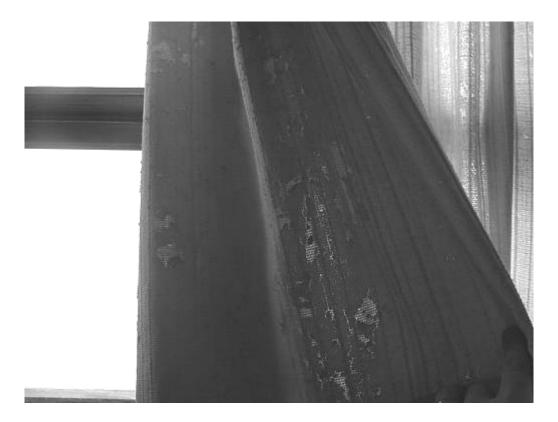
Disintegrating Textiles Classroom Curtain

- 22. Replace old/disintegrating textile curtains.
- Ensure windows are utilized during photocopying to provide air exchange in room206-A. Consider installing local exhaust fan in this area.

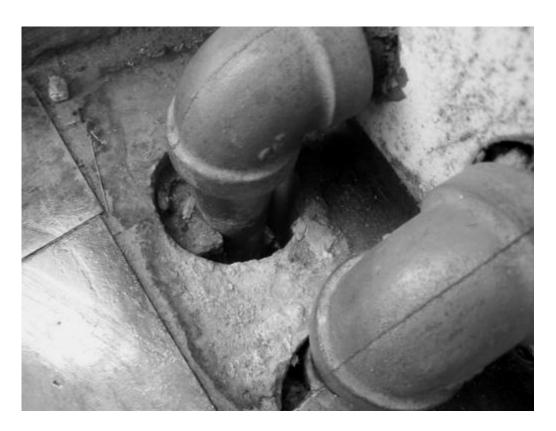
Open utility holes were observed around univent pipes (Picture 16). Efflorescence and rust was observed on the cement floor and pipes, indicating moisture penetration to the area. Light from the outside was also observed penetrating through a seam in the exterior wall (Picture 17). As with breaches, utility holes can provide pathways for drafts, dust, odors and moisture. These utility holes should be sealed to prevent drafts, moisture and movement of materials to the interior of the building.

Open Utility Holes around Univent Pipes

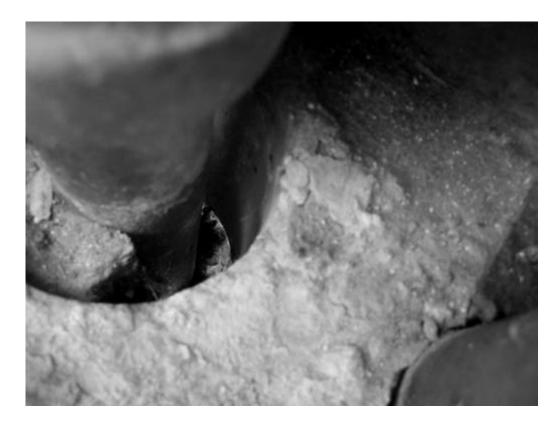
Open Utility Holes around Univent Pipes, note Light Penetrating from Exterior

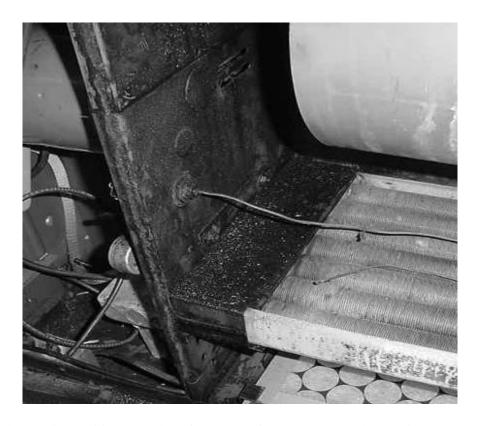
Finally a pungent organic odor was reported by the occupant in classroom 103. CEH staff determined the odor was strongest near the unit ventilator. The univent cabinet was opened and an unidentified material that appeared to be oil/fluid was observed inside the cabinet (Pictures 18 and 19). The strength of odors would be exacerbated by heat created by the univent. These odors could then be drawn into the unit and distributed throughout the classroom via the univent fan. The source of the odors shared with BMS maintenance staff, and CEH staff recommended that it be cleaned prior to reactivating the univent.

Oil/Fluid inside Univent Air Handling Chamber Classroom 103 (Dark Accumulation on Left)

- Ensure oil/fluid is cleaned from the interior of univent cabinet in classroom 103.
 Monitor for continuing leaks, make repairs as needed.
- 7. Continue to make repairs to window systems to eliminate/reduce water infiltration (e.g., 300 wing and 306-A, in particular).

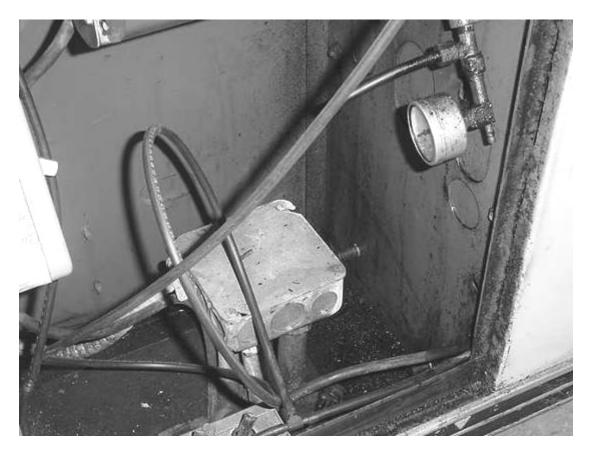
Oil/Fluid inside Univent Classroom 103 (Dark Accumulation on Right Bottom/Sides)
